# **CUNNINGHAM PRESERVATION PROJECT**

## **GRAND TETON NATIONAL PARK MOOSE, WYOMING**

### **HISTORIC STRUCTURES RECORD OF TREATMENT**

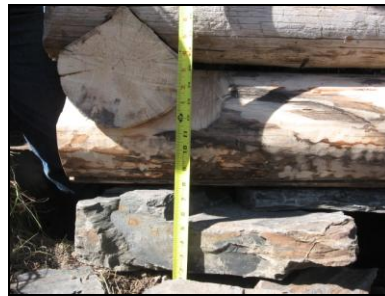
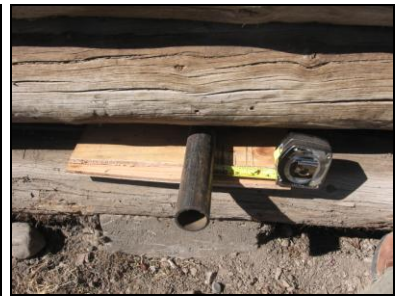
The two photographs on the right show the movement of the building vertically and horizontally. In the first photo, the new sill log had been put in place and is supported by new field stone taken from a local source. The second photo shows a movement of approx. 3 inches of the northwest corner of the north room.

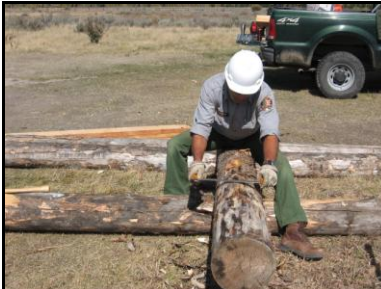
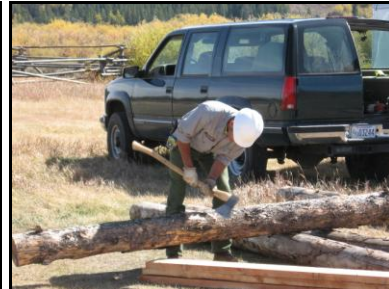
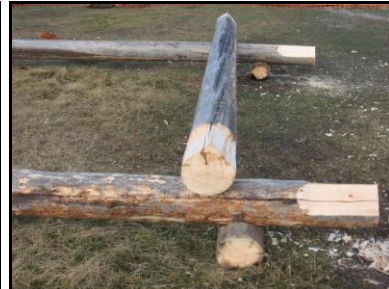
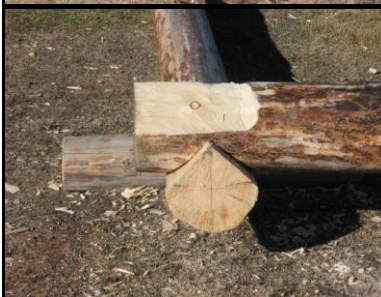
All eight sill logs were in need of replacement on Cunningham Cabin. Hand tools were used to peel the logs and create notches. The logs were replaced in-kind.

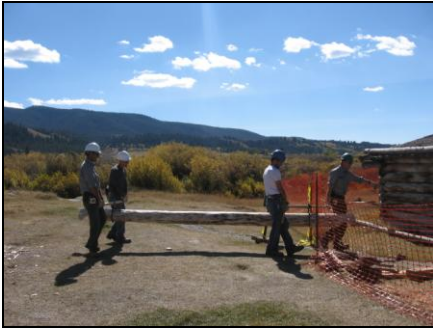
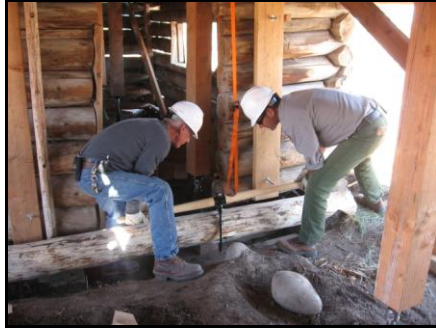
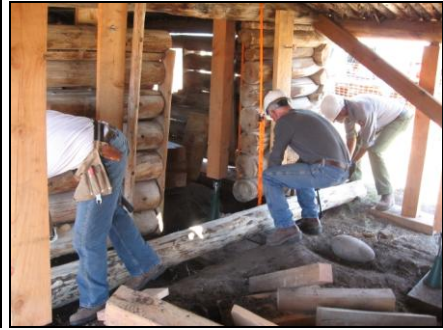
All six photos shown here are of the sill logs being replaced in the north room.
